Use of Structures to Aid in the Creation of Emergent Sandbar Habitat

Chris Svendsen, P.E.

Omaha District Corps of Engineers

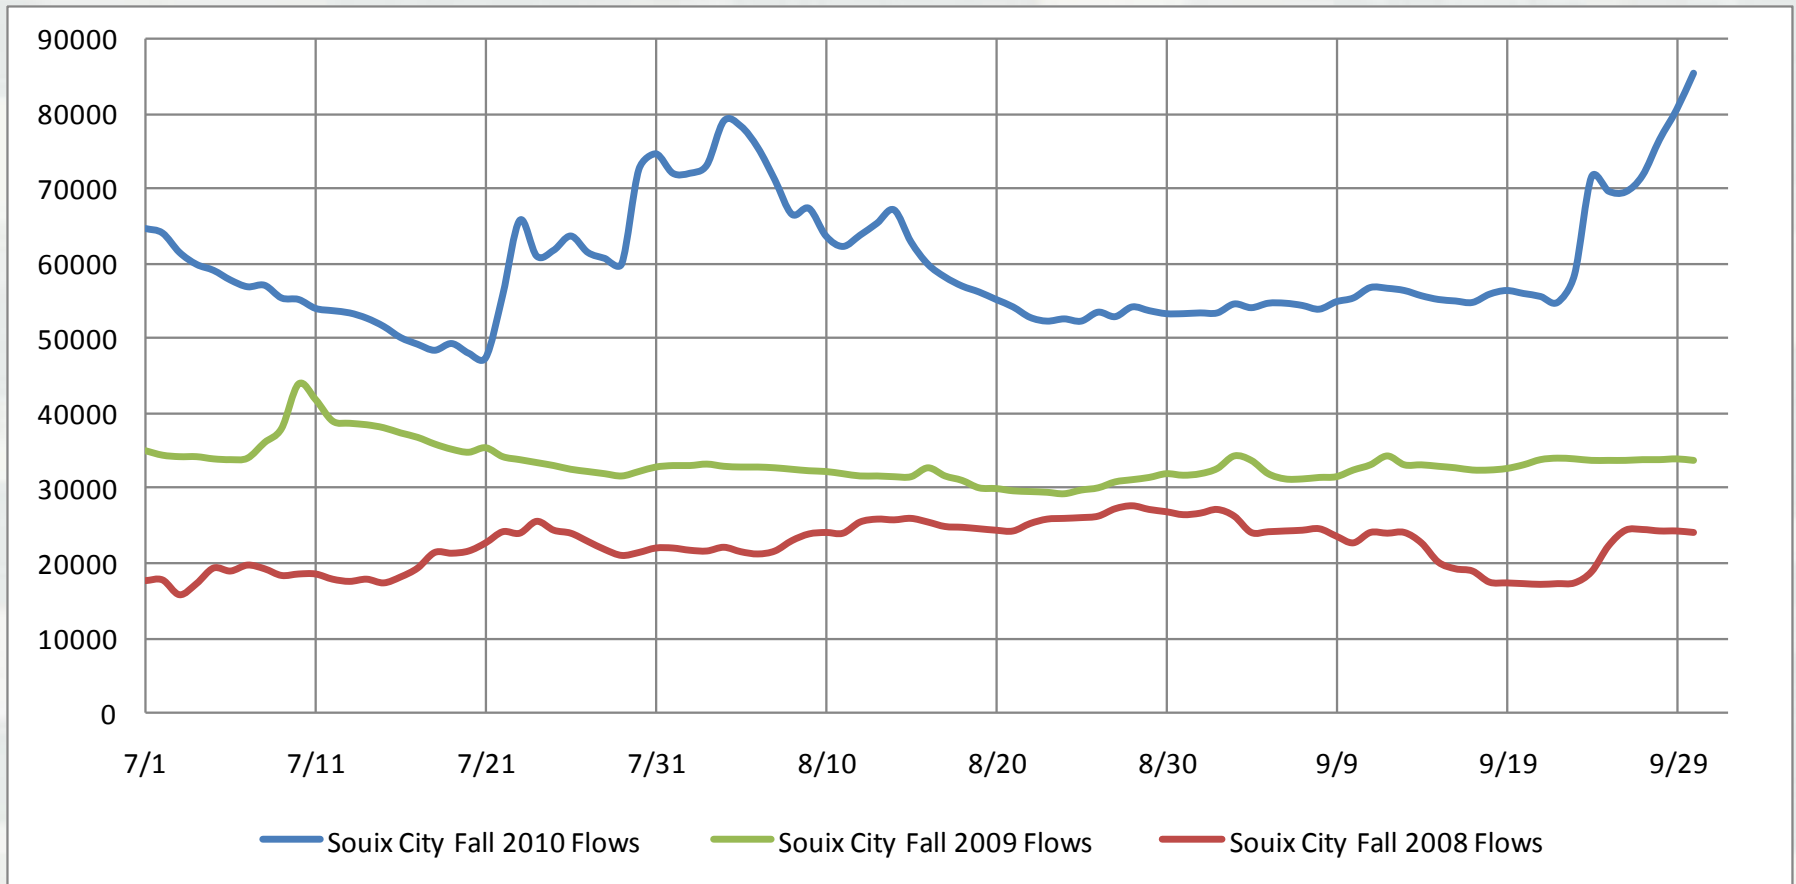
Missouri River Flows @ Souix City

Jun-Oct 2008-2010

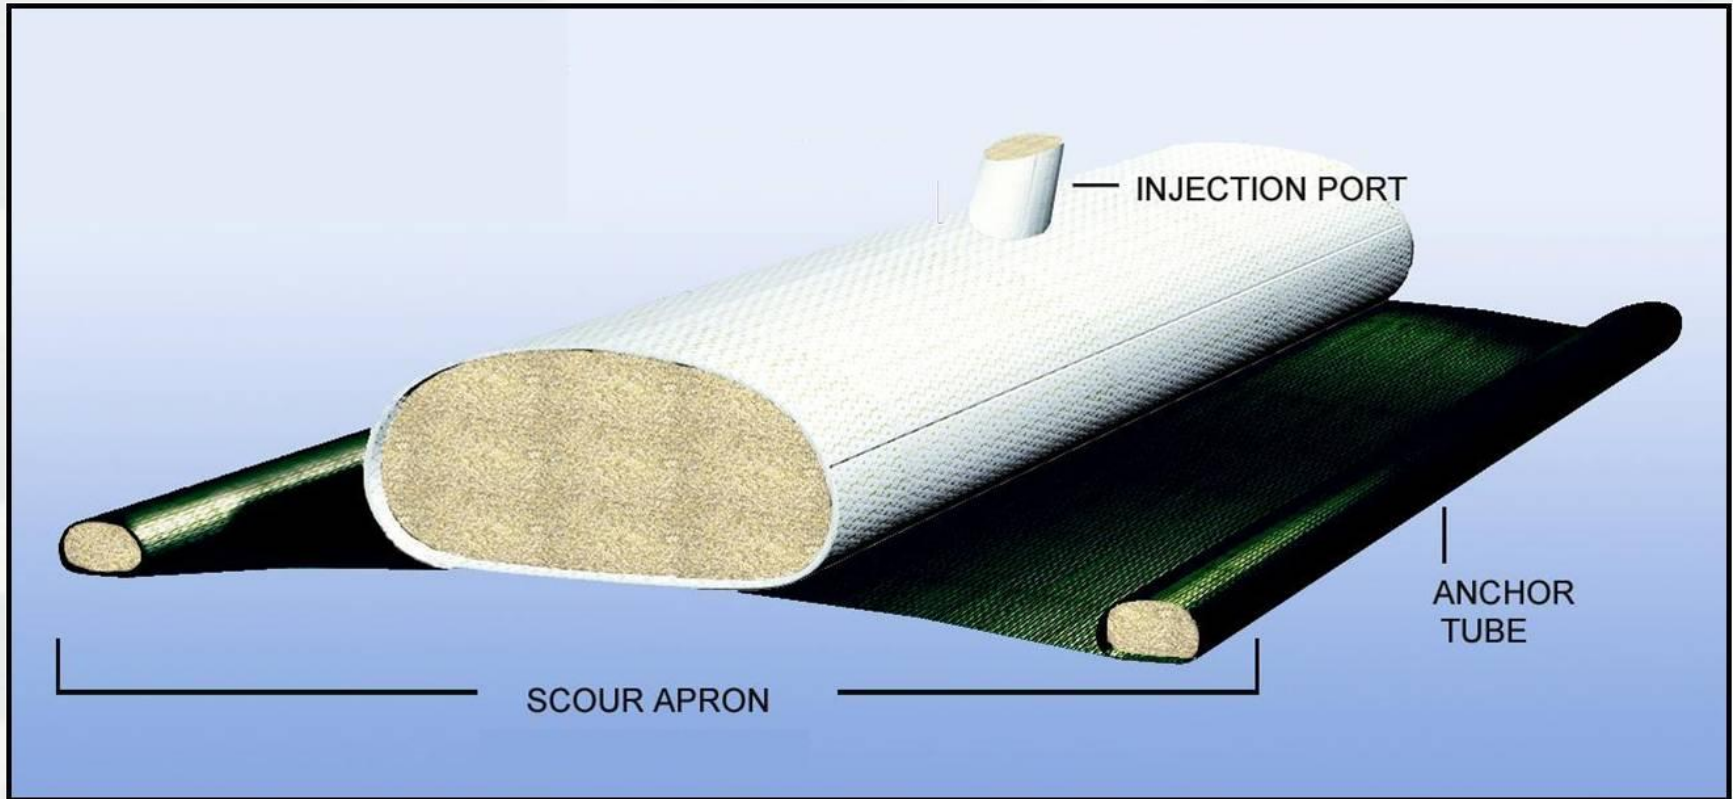
Geotextile Tube Structures Overview

Typical Applications: Shoreline Jetties, Beach Protection/Rehabilitation, Soils Dewatering, Wetlands Protection/Rehabilitation.

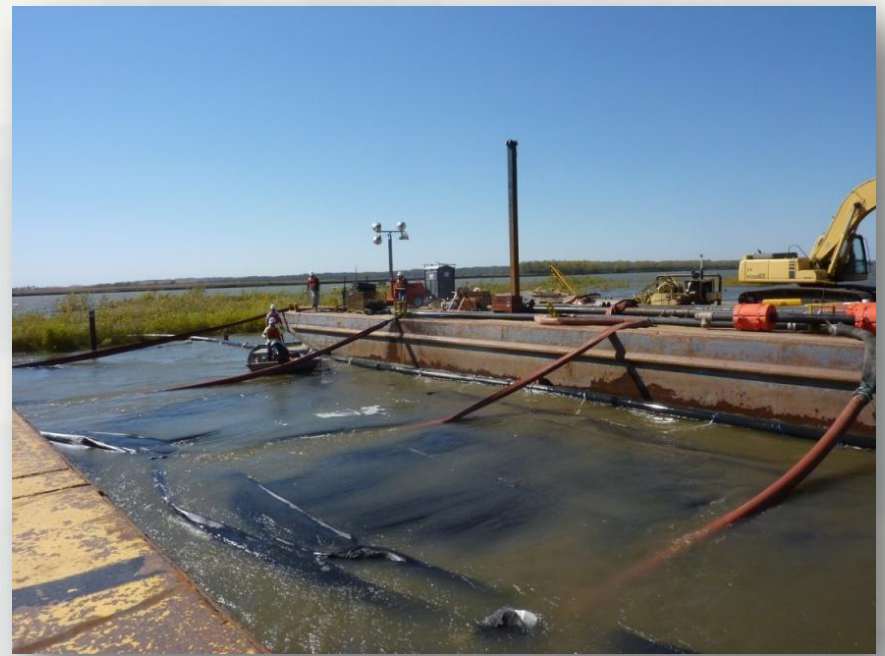
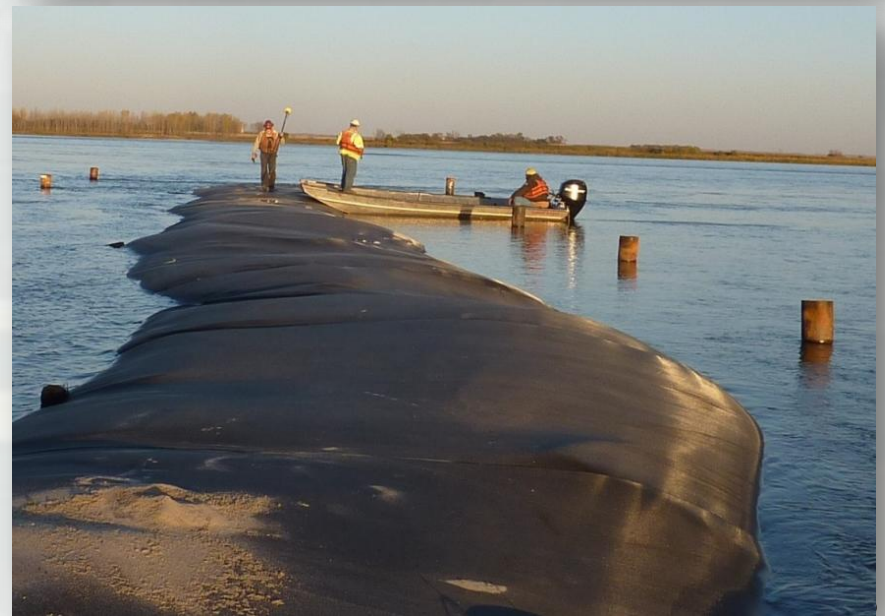
- 40' circumference tube supported by underlying scour mattress.
- Fillable by dredge through evenly spaced fill ports.
- Fill heights variable from 3 to 8 feet.
- Variable lengths (150' – 250' per tube for this project)

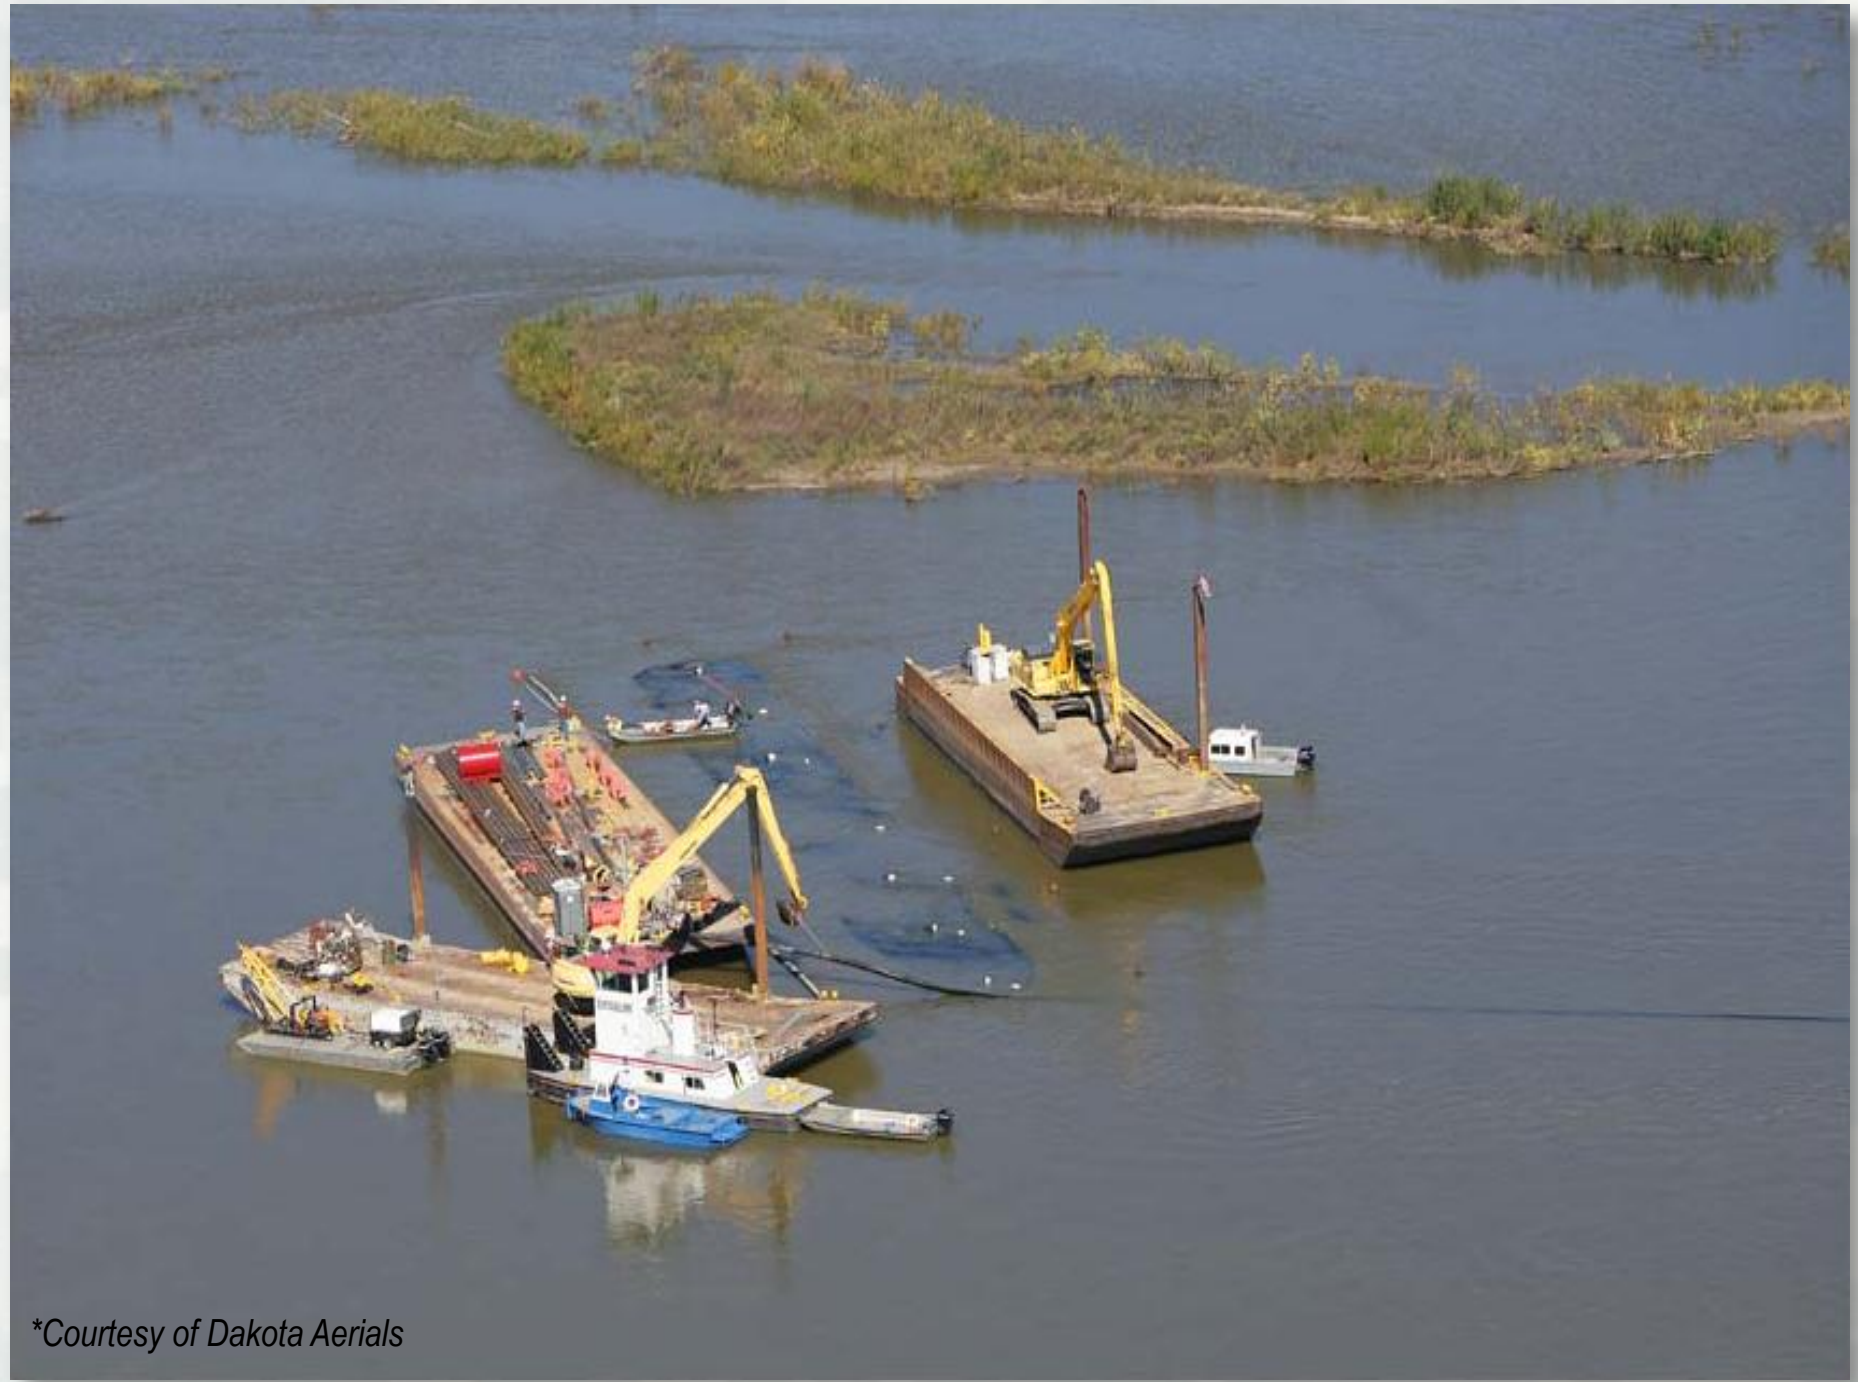
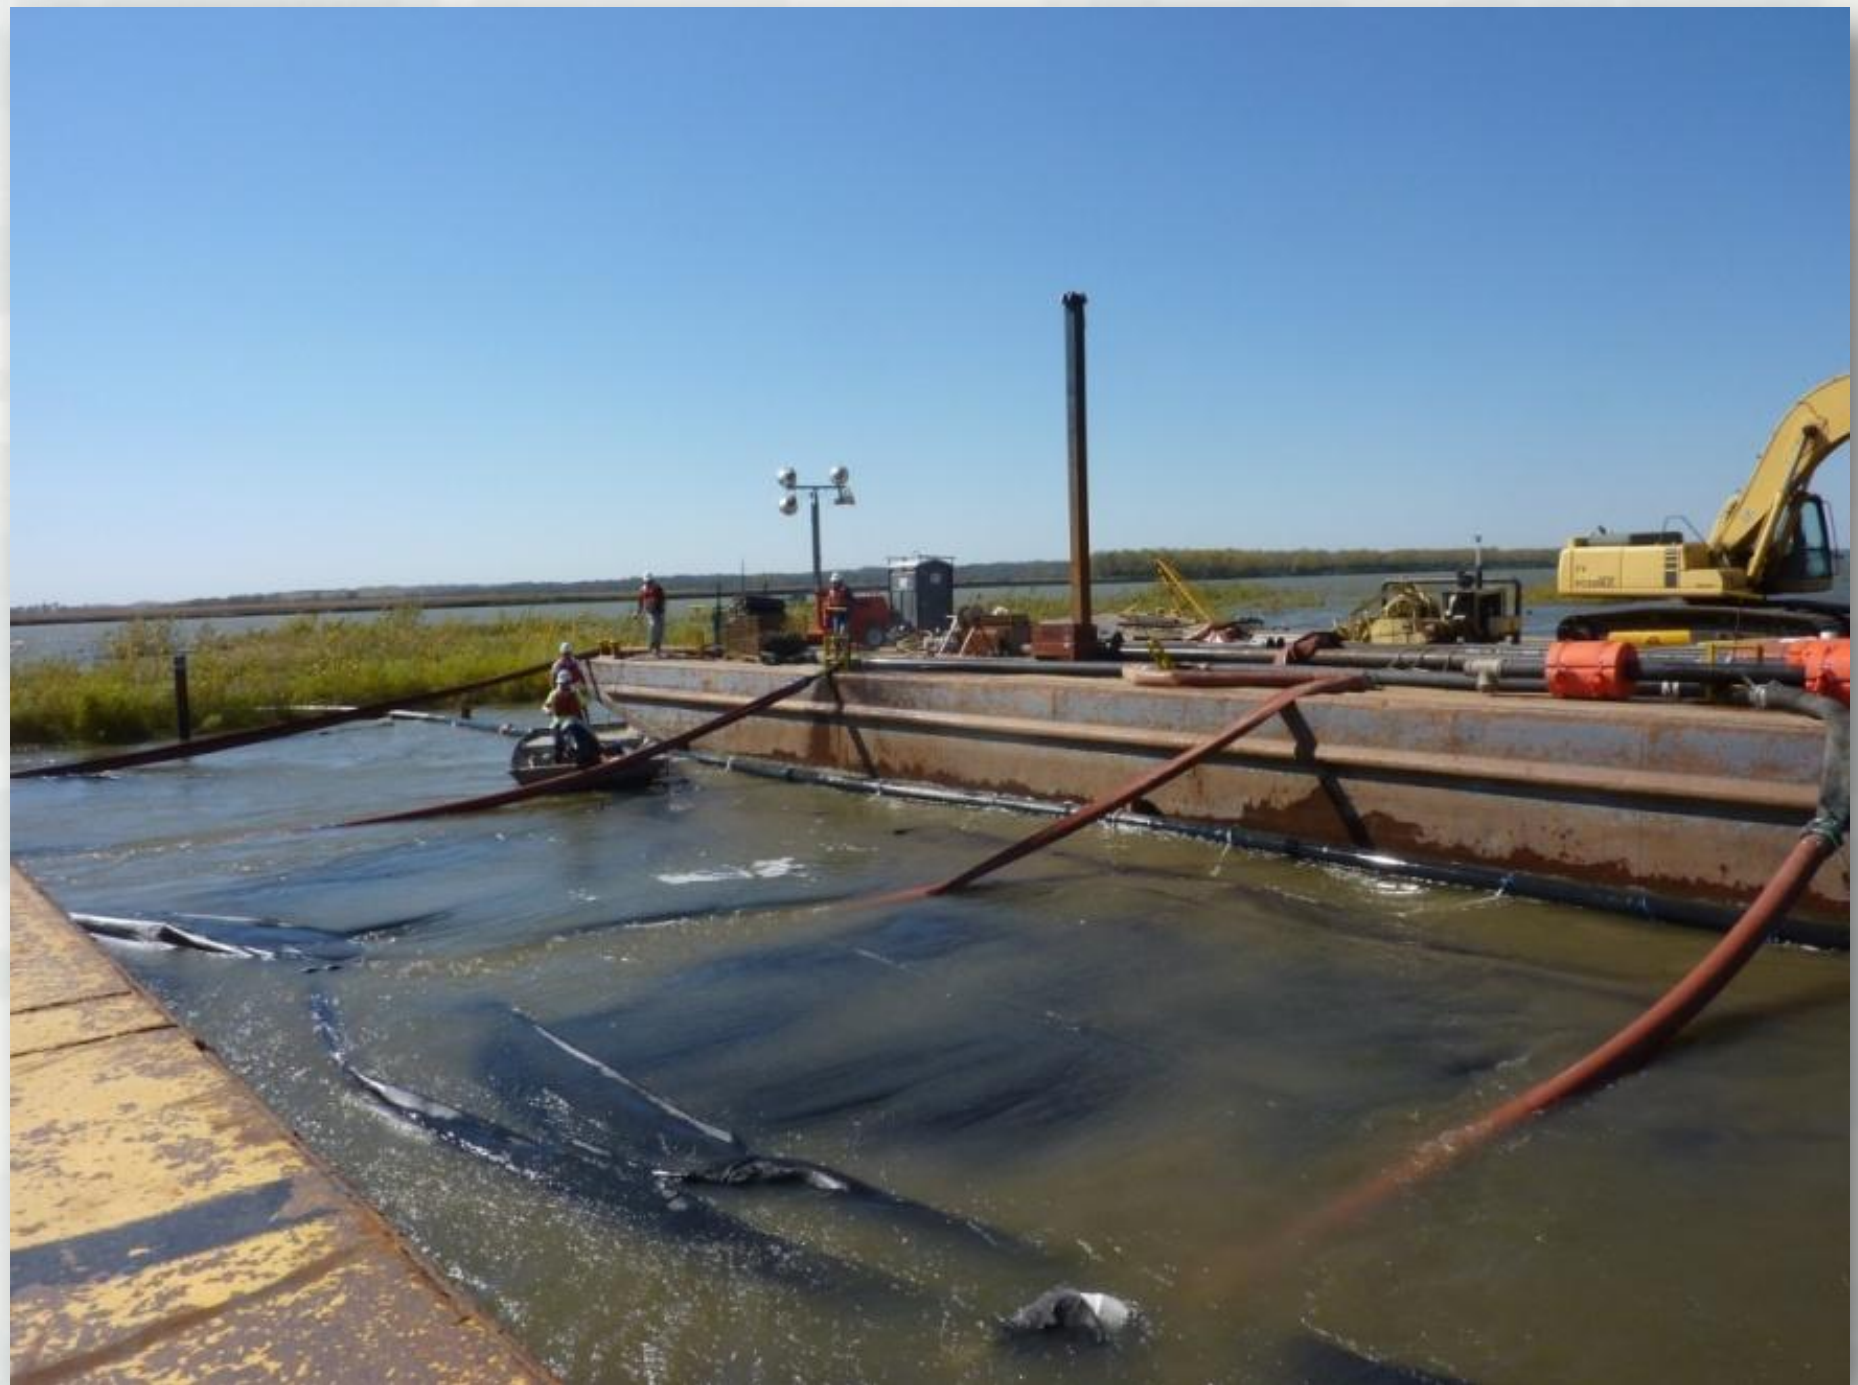
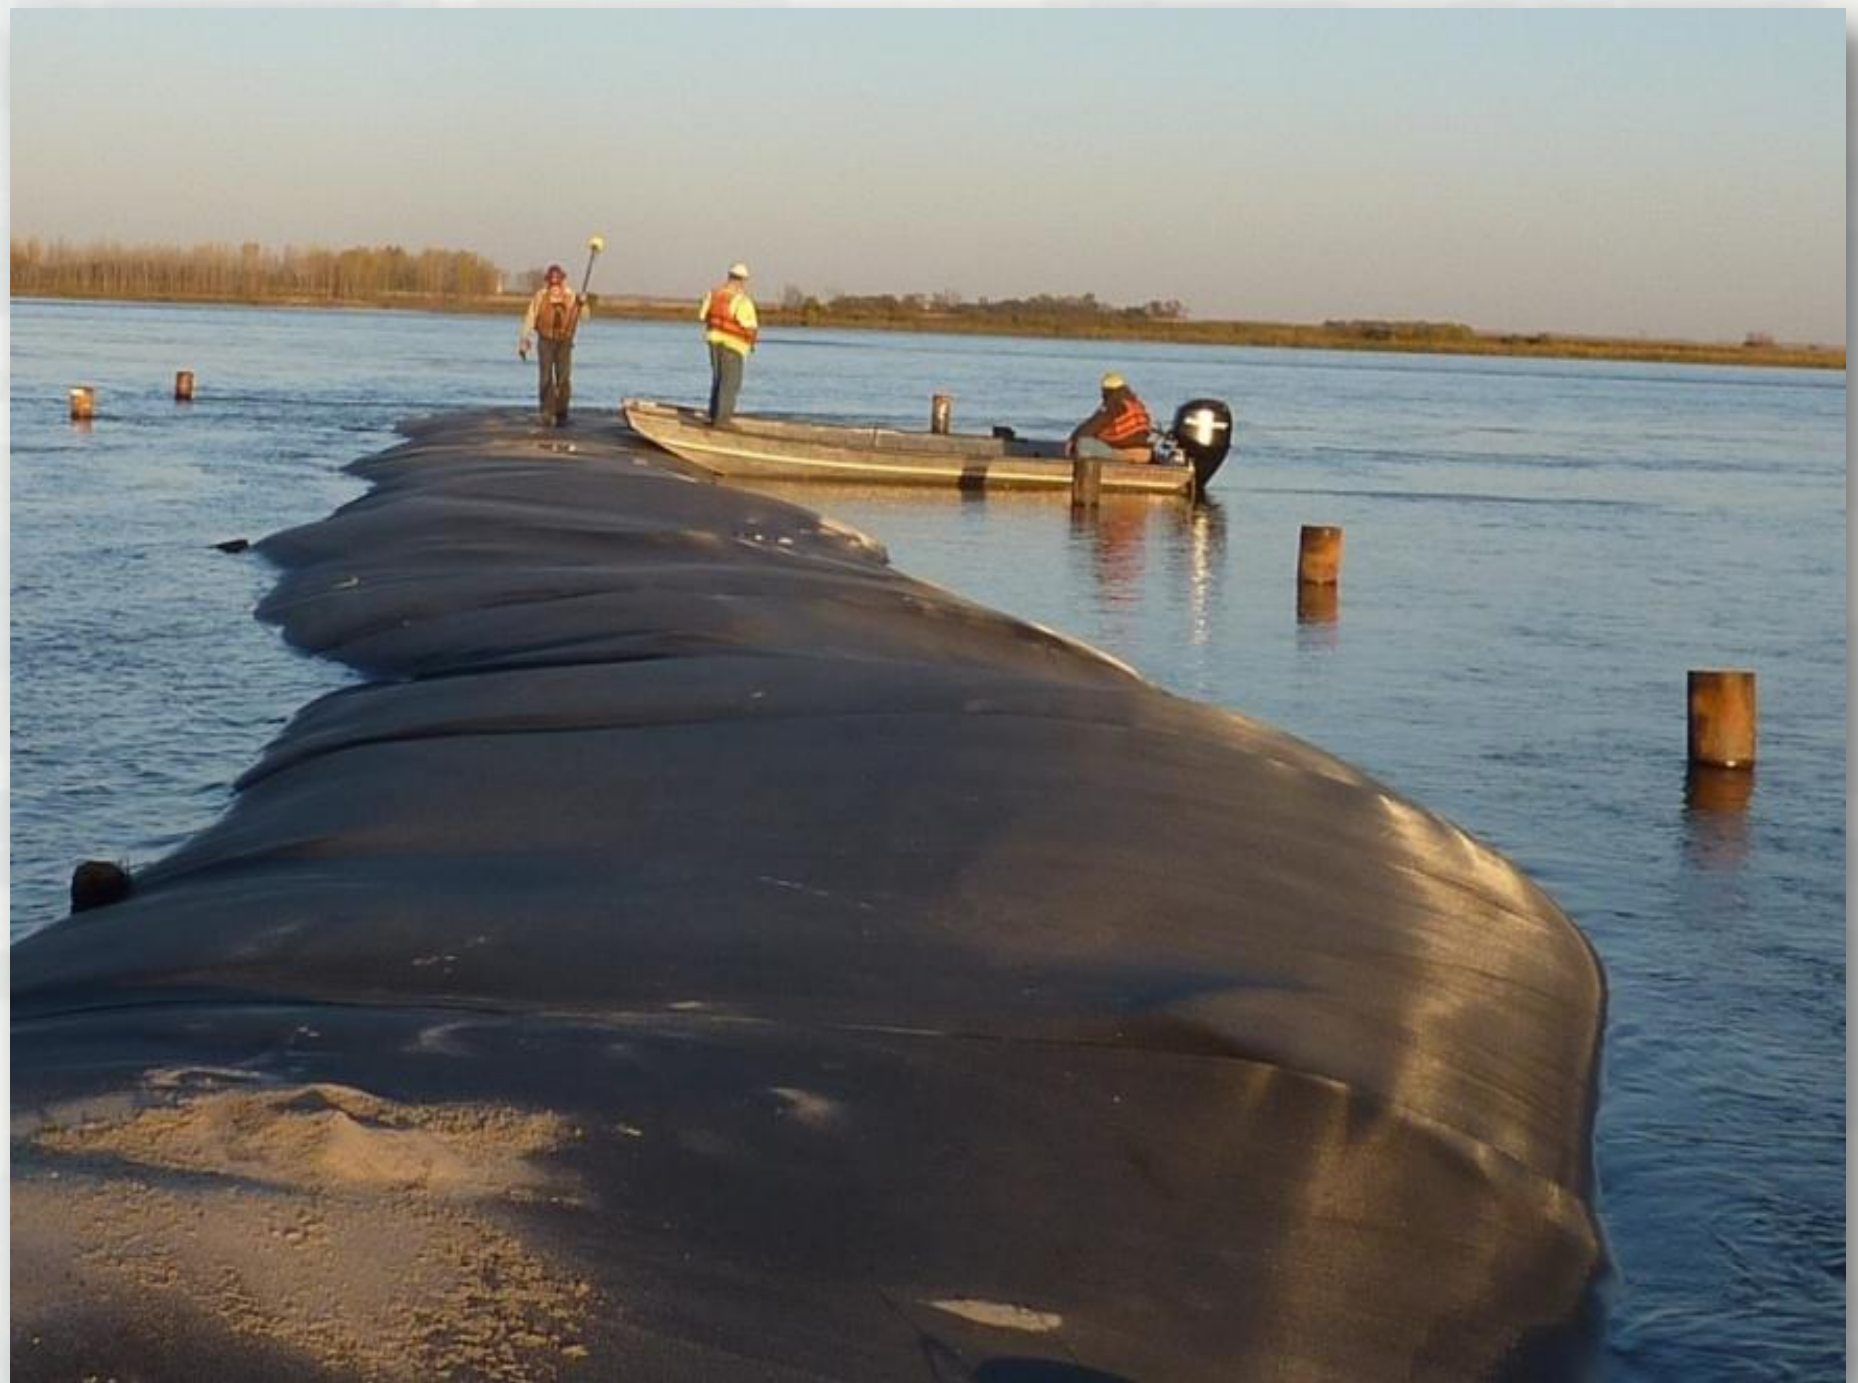
Deployment at RM 789.6

Construction Experience

- Depths at time of construction had changed since pre-construction surveys.
- Construction equipment could not operate freely in depths <3.5'.
- Straps on tubes were subject to failure in depths generally >5'.
- Scour around installed tubes prohibited installation tubes in adjacent configurations.
- Two 200' tubes installed before contractor was instructed to proceed to next site.
- Mid September thru Early October

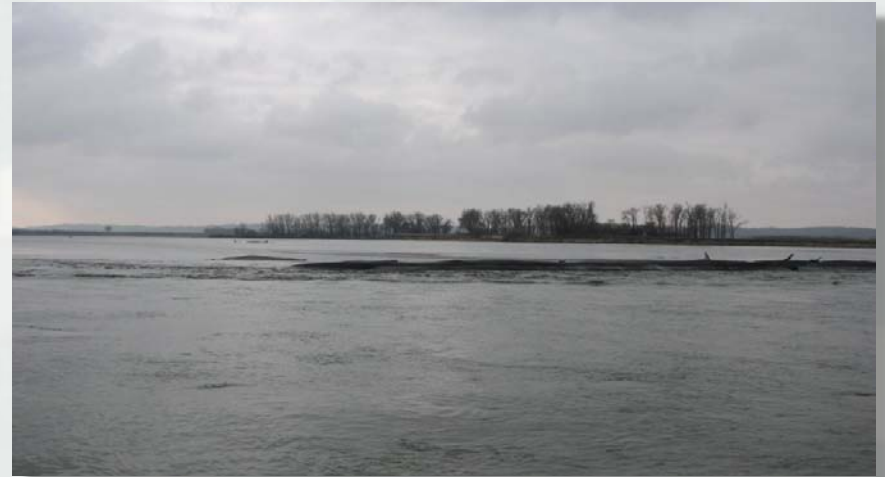
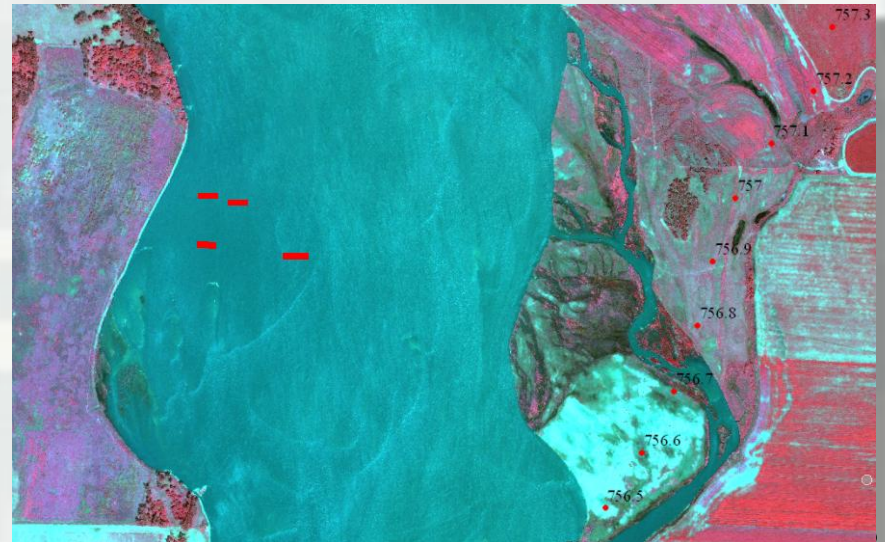
Deployment at RM 757.7

- Insufficient Depths and Vegetation required relocation of tubes
- Depths and Velocities ideal for placement after experiences at 789.6
- With ideal conditions, still experienced failure of tubes during installation.
- High winds and inclement weather delayed deployment
- Construction halted after installation of four tubes due to safety and schedule concerns. (October 21, 2010)
- Project at RM 759 modified to dredging, which resulted in 5 to 10 acres of habitat created.
